## MEMORANDUM

**DATE:** May 27, 2026  
**TO:** Dale Kaemingk, Mayor, City of Brier  
**FROM:** John Forba, PE  
**SUBJECT:** Brier Road-Crosswalk Analysis

The City of Brier has asked PACE Engineers to analyze the traffic conditions on Brier Road specifically if the current conditions/regulations warrant pavement markings for a crosswalk across Brier Road at the Brier Public Library located on Brier Road between 232nd Street SW and 236th Street SW.

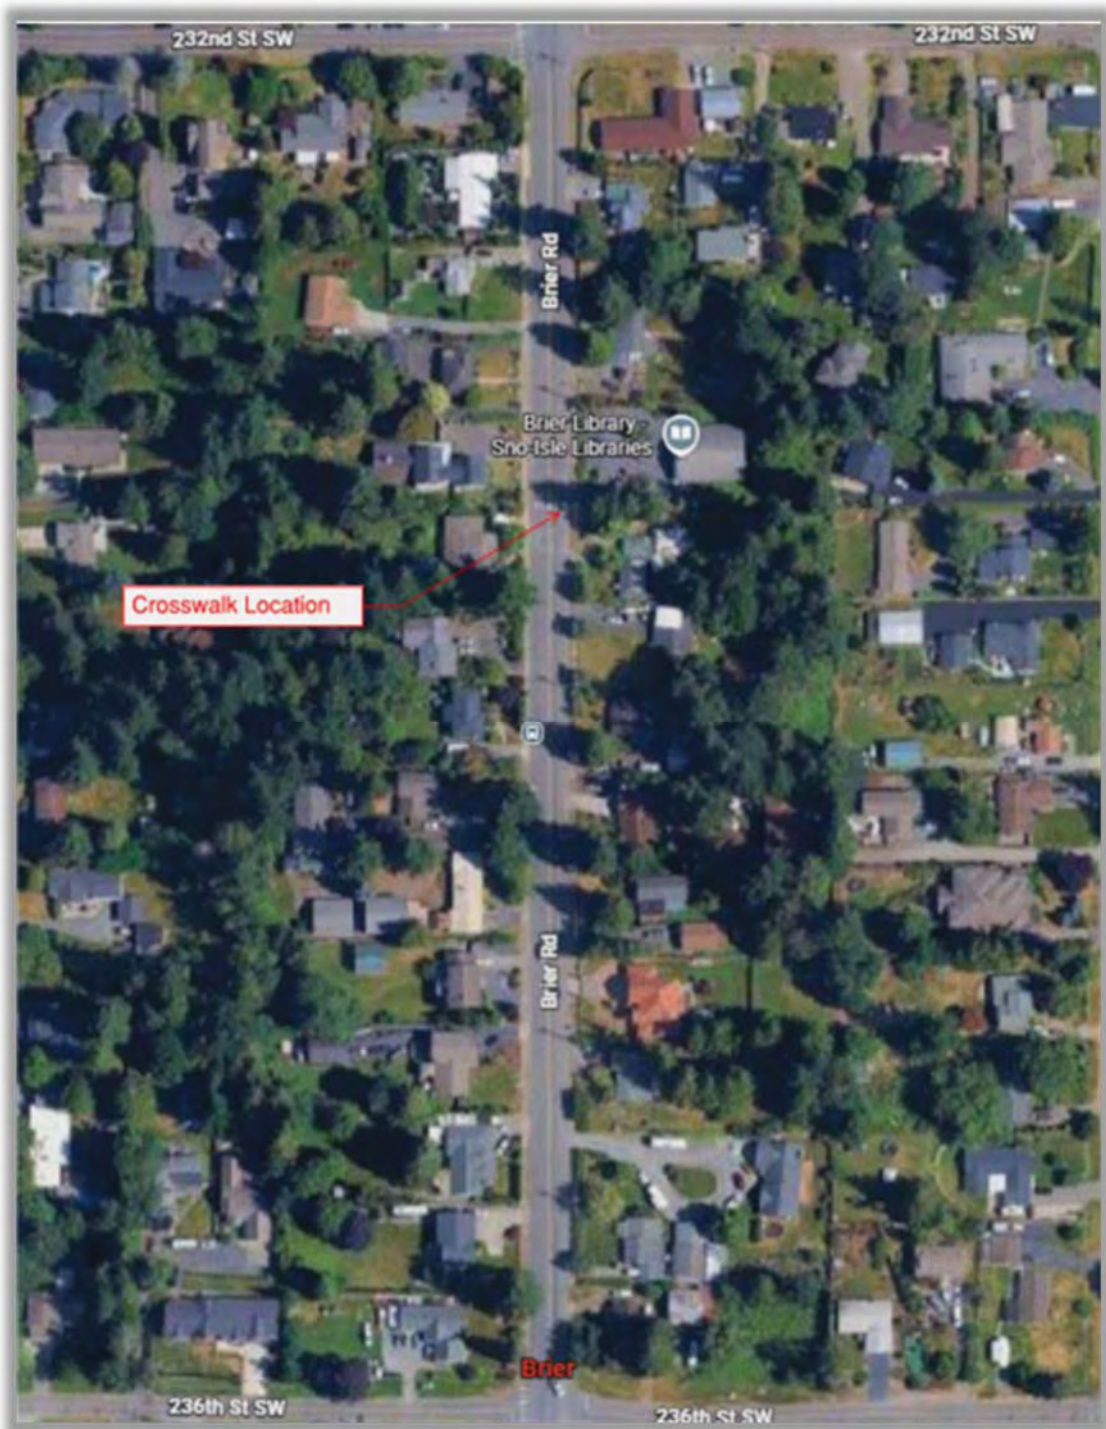
*Figure 1 - Project Site Map*

Brier Road runs North-South through the City from the southern City limits with the City of Lake Forest Park north approximately 1.75 miles to the intersection of Old Poplar Way where the two roads combine and transition to Poplar Way which continues north approximately 0.60 miles to the northern City limits. Per the City's 2024 Comprehensive Plan, roadways within the City are classified as "Collector Arterials", "Non-Arterials", "Neighborhood Streets" and "Local Neighborhood Streets". Brier Road/Poplar Way is classified as a Collector Arterial which has traffic counts that are greater than 3,000 vehicles a day.

### **See Figure 1 - Project Site Map.**

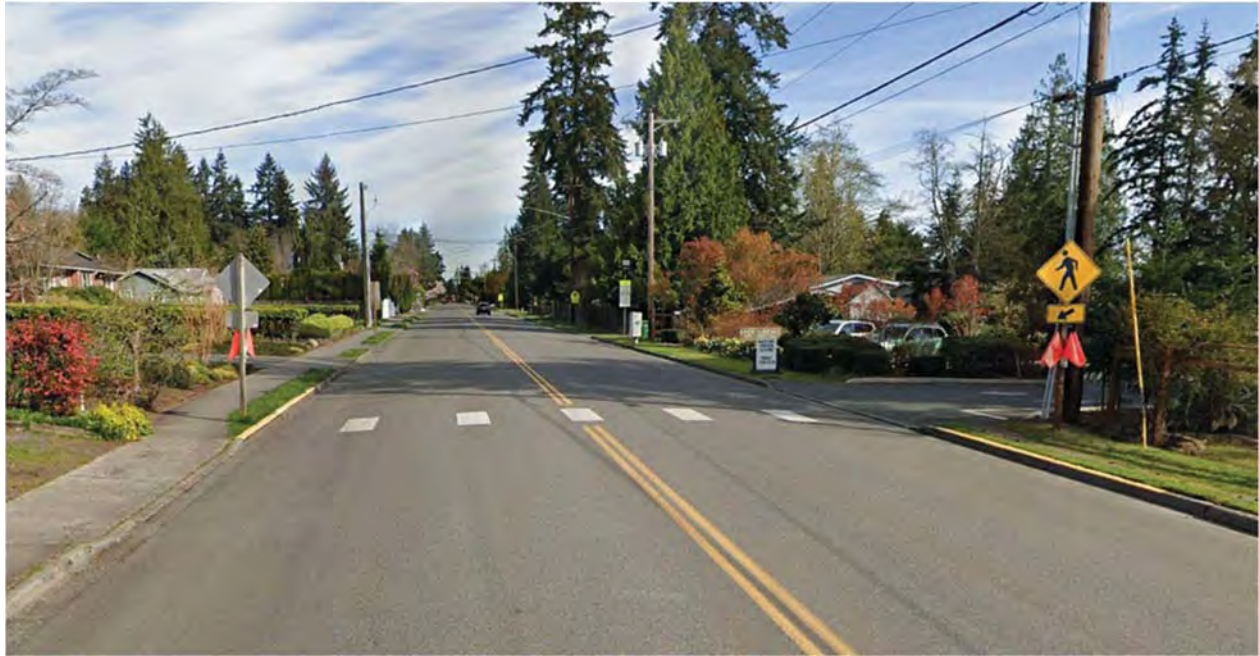
*Figure 2 - Image of Crosswalk Looking North*

The existing crosswalk on Brier Road is located approximately 450 feet south of the Brier Road/232nd Street SW intersection, constituting a “mid-block” crossing (i.e., not located at an intersection). While mid-block crossings can enhance pedestrian safety in certain contexts, they typically require supplemental treatments such as curb extensions (bulb-outs), pedestrian refuge islands, or pedestrian-activated Rectangular Rapid-Flashing Beacons (RRFBs).

Absent these enhancements, mid-block crossings can reduce safety. Drivers may not anticipate pedestrian activity at mid-block locations, increasing the potential for conflicts. Additionally, marked crossings without supporting treatments can create a false sense of security for

Because the City's crosswalk functions as a mid-block crossing and does not connect to an ADA-compliant Pedestrian Access Route (PAR) at either end—due to the absence of compliant curb ramps—it is our opinion that this location should not be maintained as a marked crosswalk.
